HOUSATONIC RIVER BASIN  
WASHINGTON, MASSACHUSETTS

SANDWASH DAM  
MA 00316

PHASE I INSPECTION REPORT  
NATIONAL DAM INSPECTION PROGRAM

AUGUST 1981

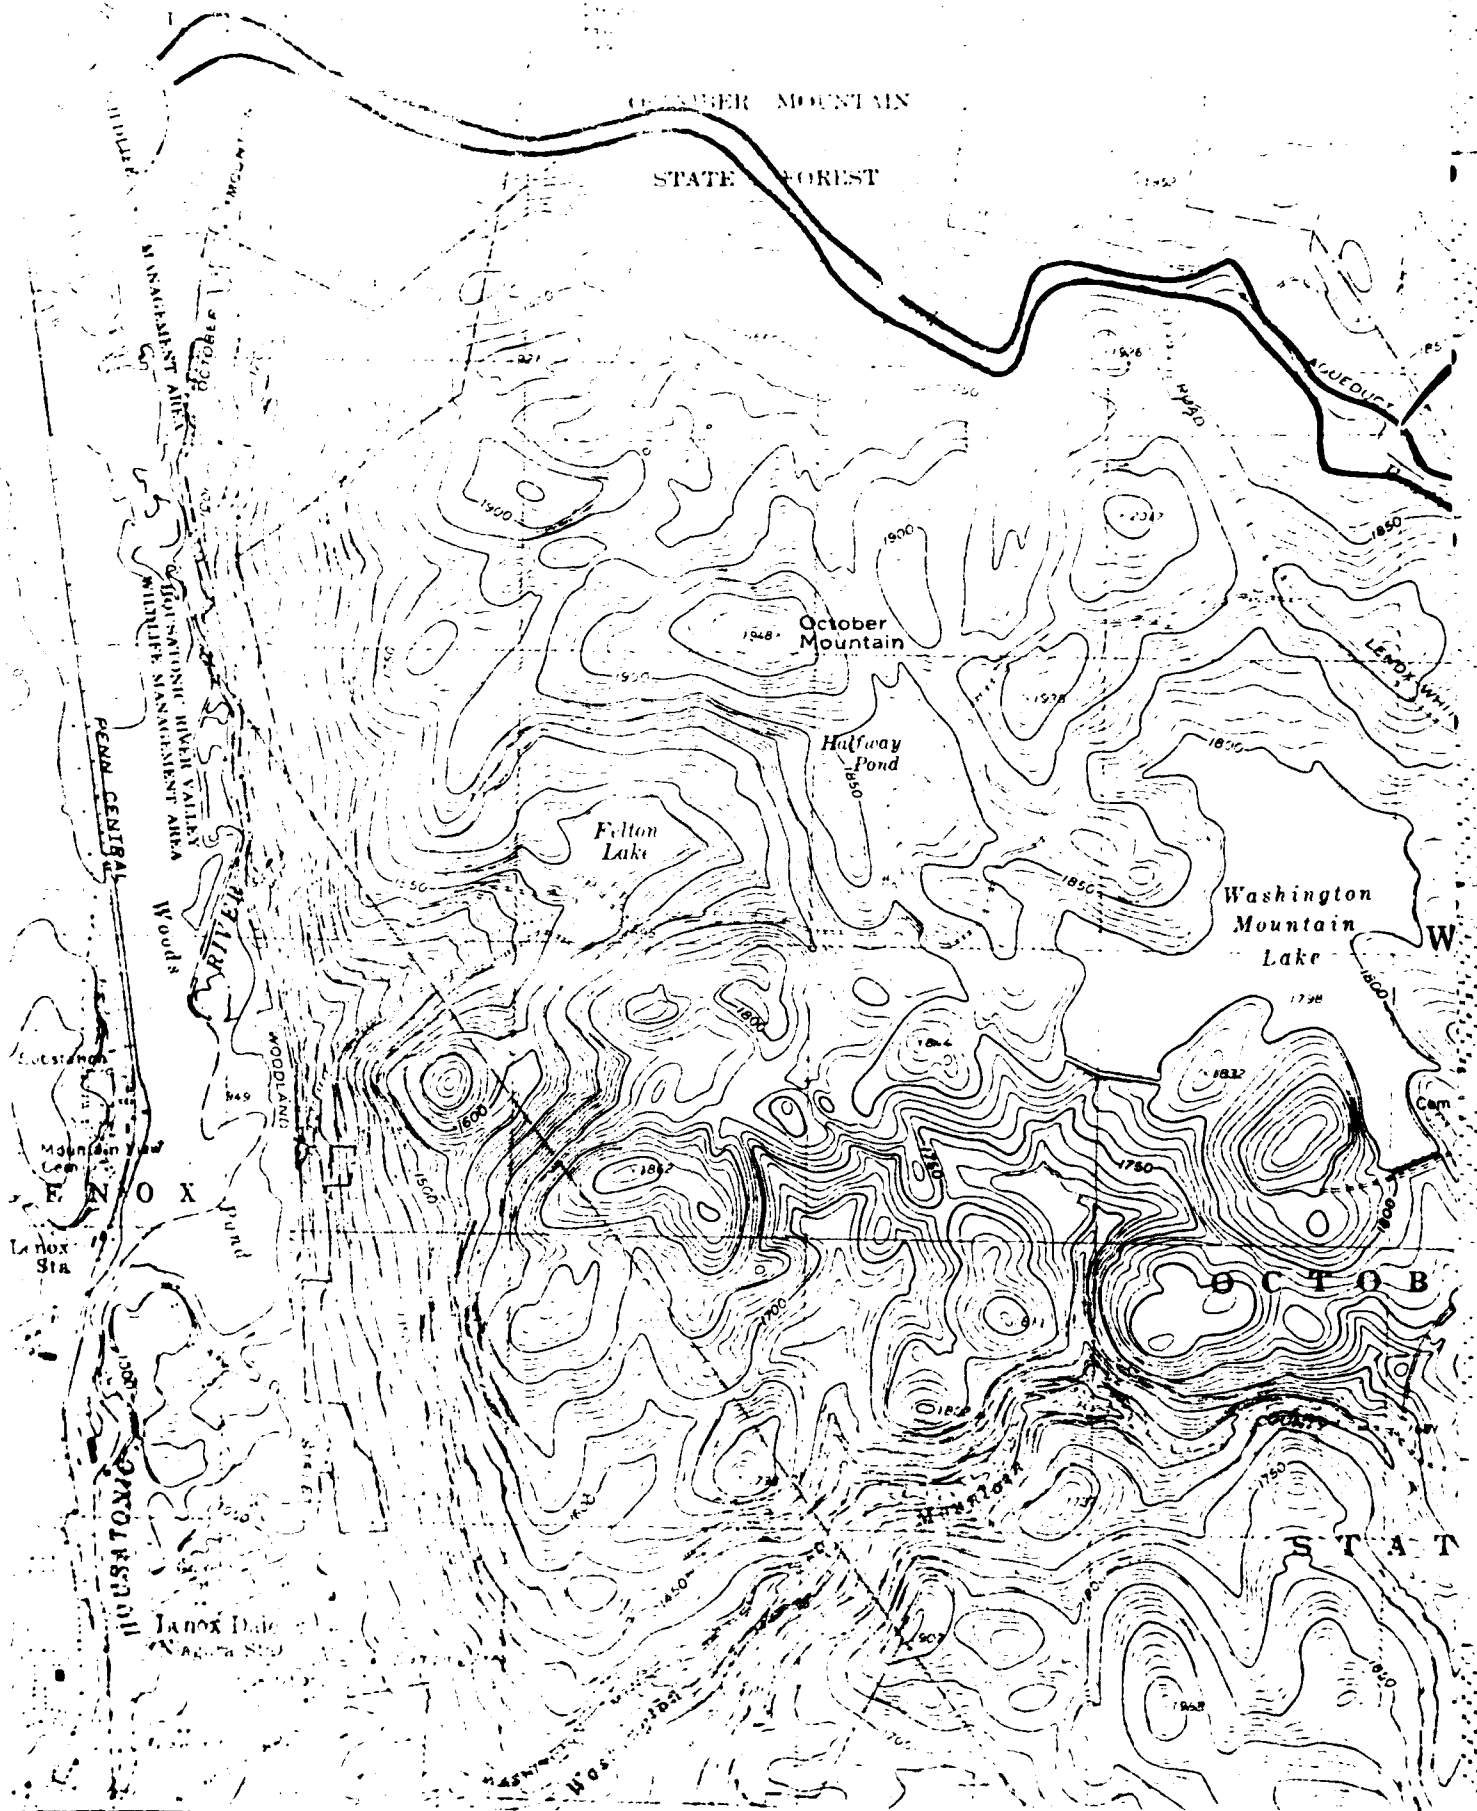
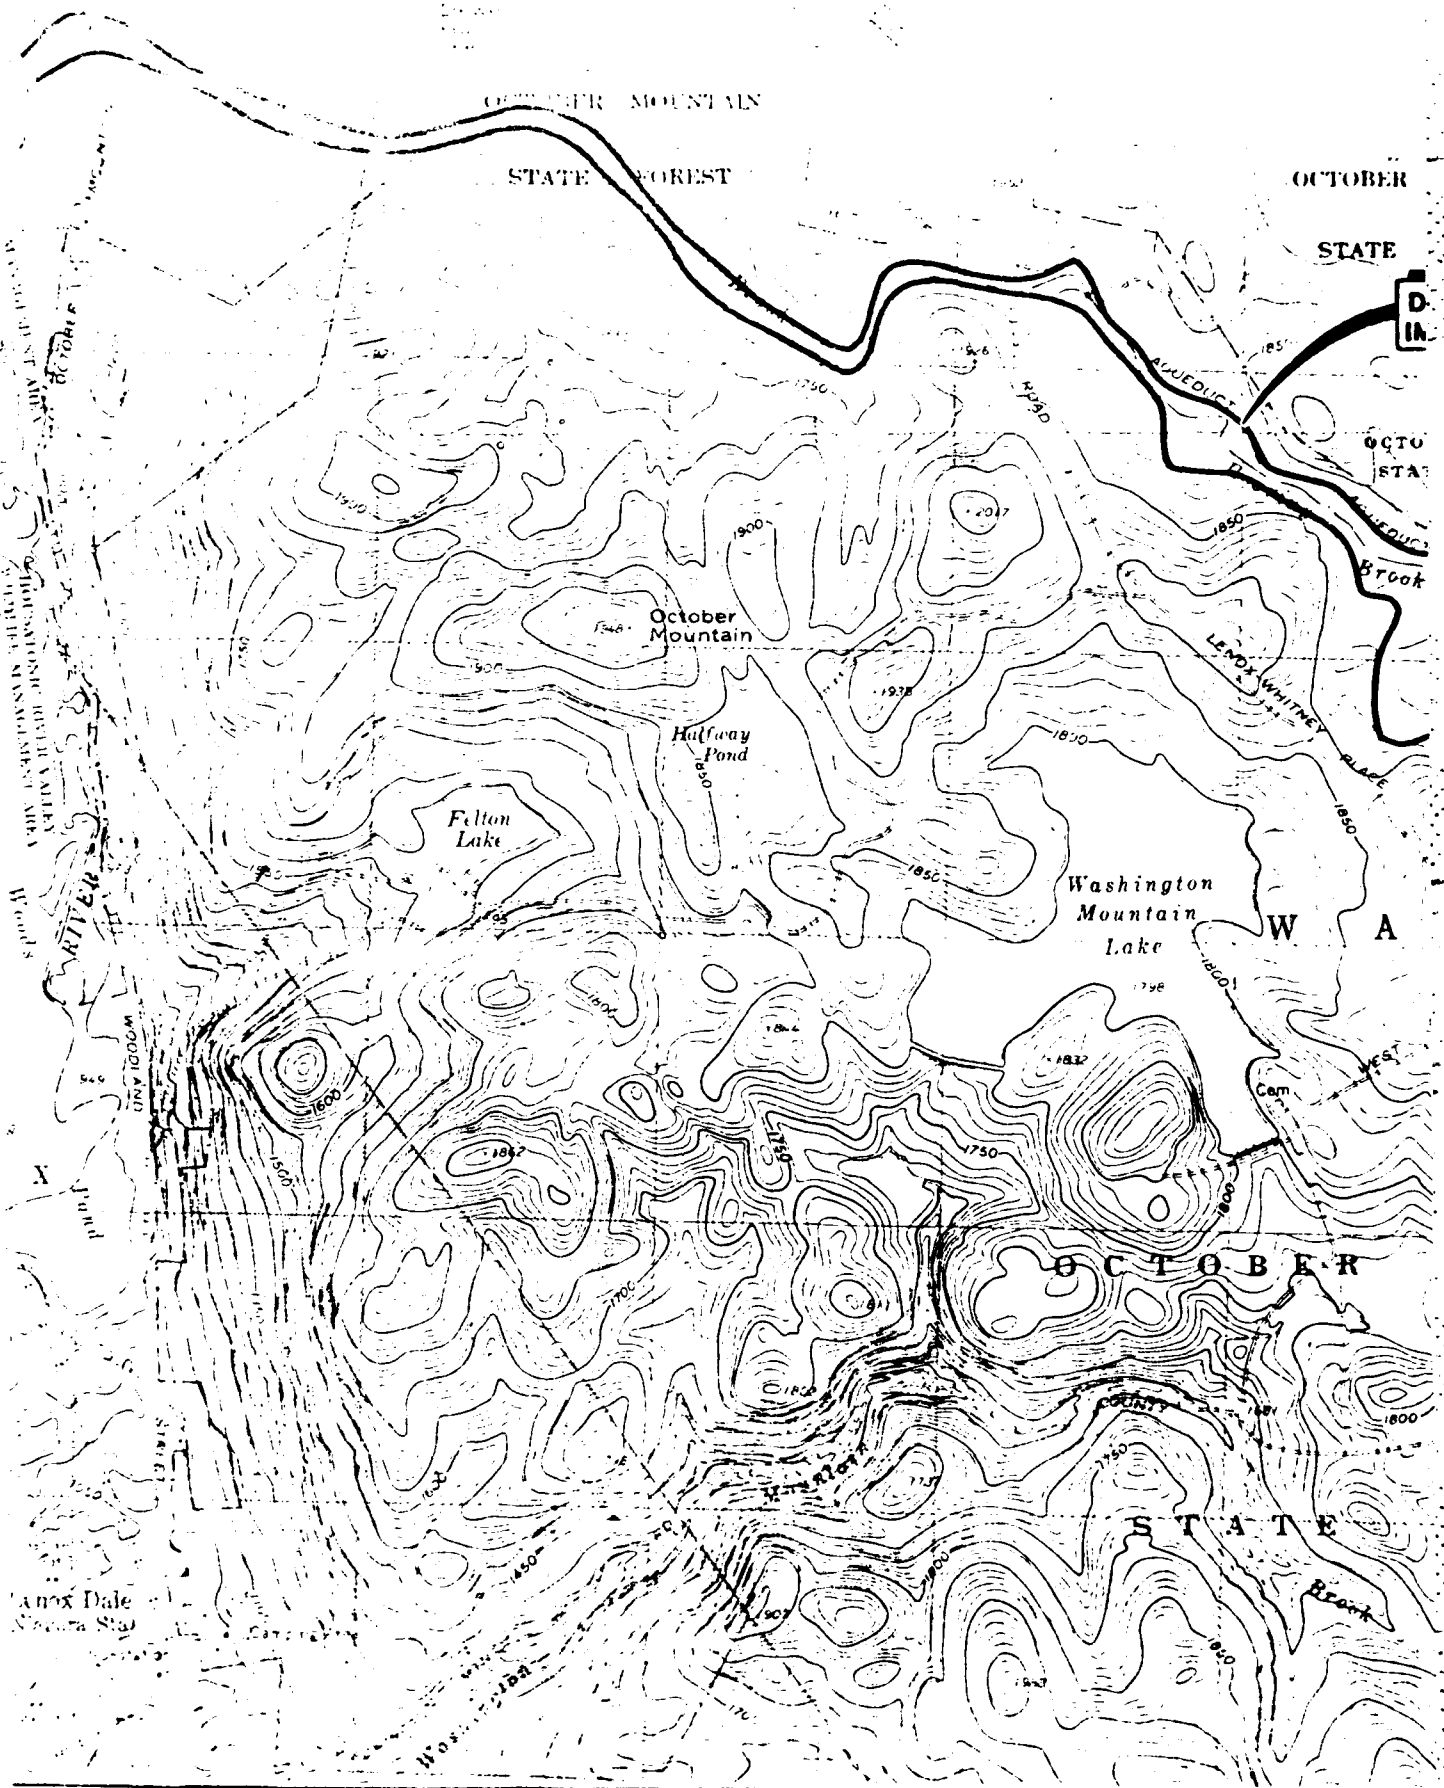
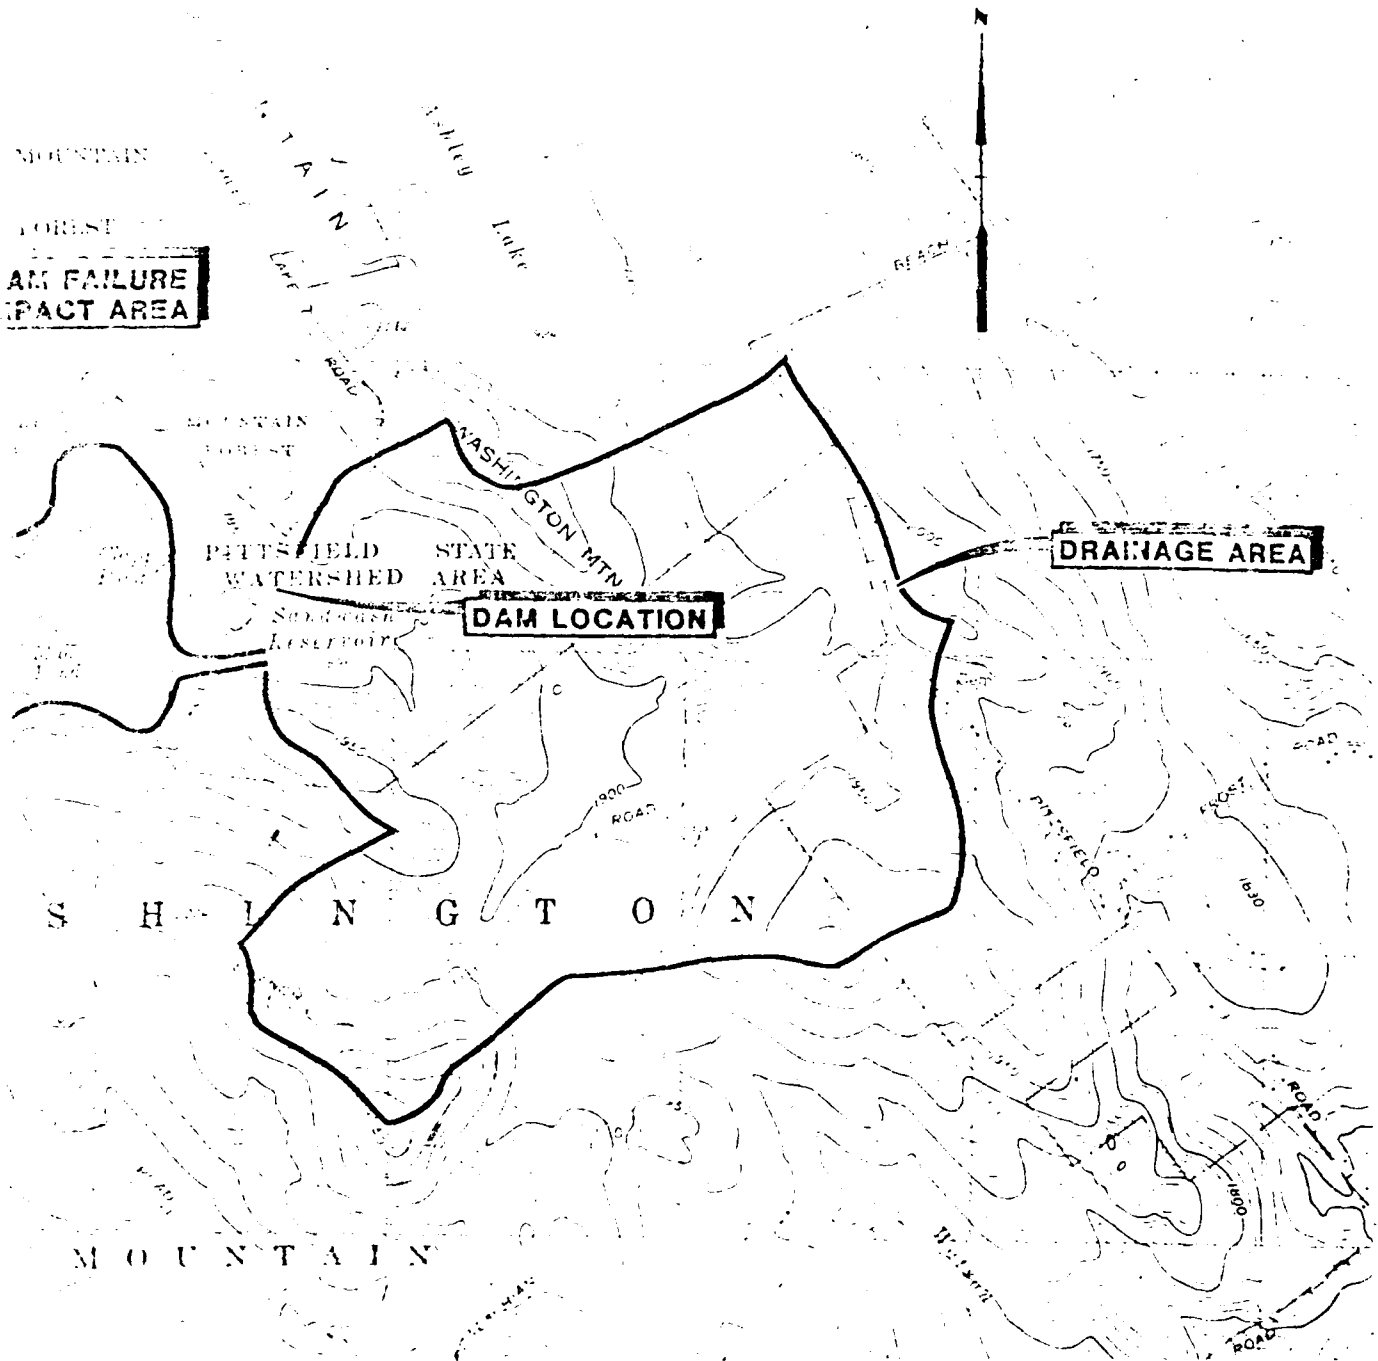
SANDWASH DAM  
DAM FAILURE IMPACT &  
DRAINAGE AREA

Hazard Class is Significant  
impacts 3 roads & 1 house  
by 1± ft. of water.
